INSPECTION CONDITIONS

FILE #: 200710-111
DATE OF INSPECTION: 10/18/07.
TIME OF INSPECTION: 8:00 AM. to 10 PM
CLIENT NAME: Mr. X
CLIENT CITY/ STATE/ZIP:
CLIENT PHONE #: 111-1111
CLIENT FAX #:
INSPECTION SITE CITY/STATE/ ZIP: Cape Coral Fl 33990.

**MAIN ENTRY
FACES:** South.
**ESTIMATED AGE
OF HOUSE:** Built in 1975.
BUILDING TYPE: Single family concrete block construction.
STORIES: 1.

John Gardner Home Inspection Service
935 Third Street
Fort Myers Beach Fl 33931
1-239-482-0400

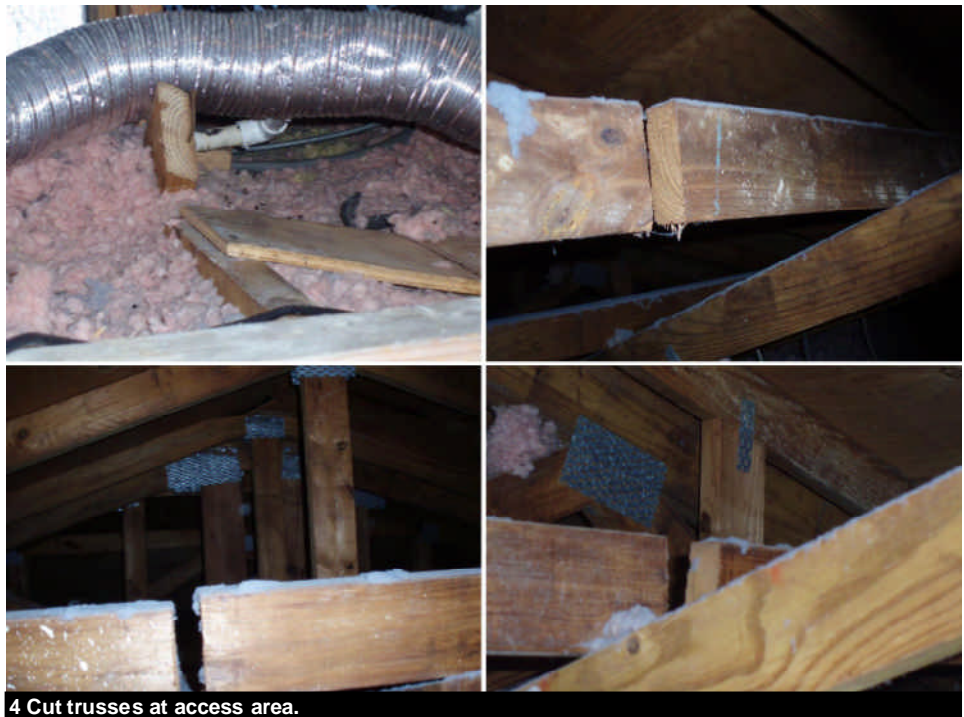
4 Cut trusses at access area.

Attic access is located in the garage. 4 Cut trusses noted in the area of front valley. Visual inspection is limited due to clearance and ducts. Suggest further review/repair by a licensed roofer/structural engineer. Evidence of rodents noted in attic.

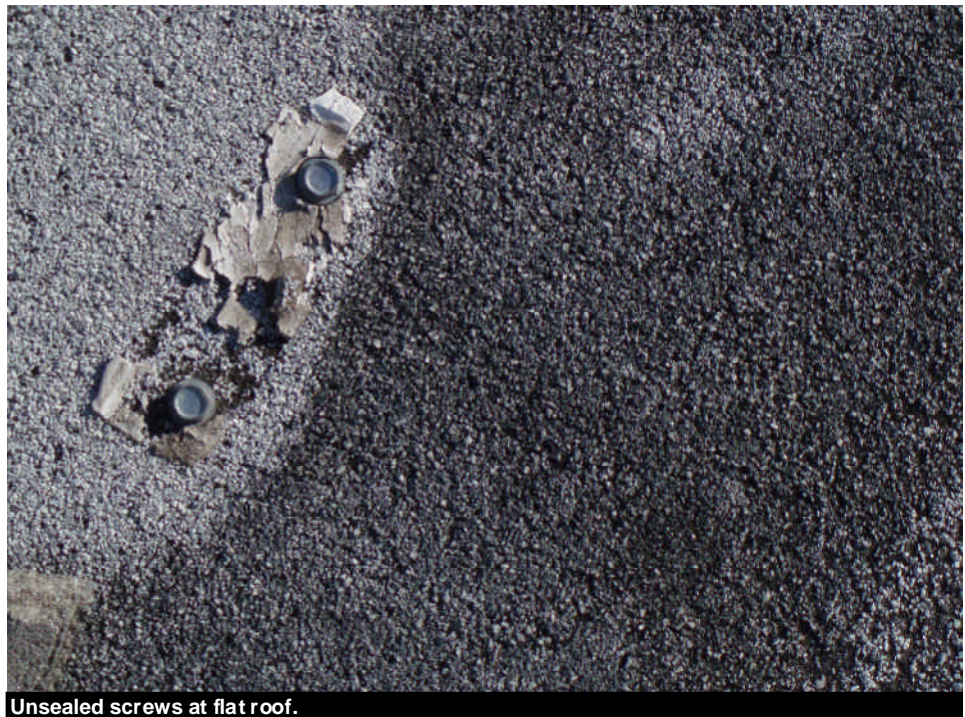
Unsealed screws at flat roof.

Unsealed screws unsealed right side. Suggest routine maintenance.

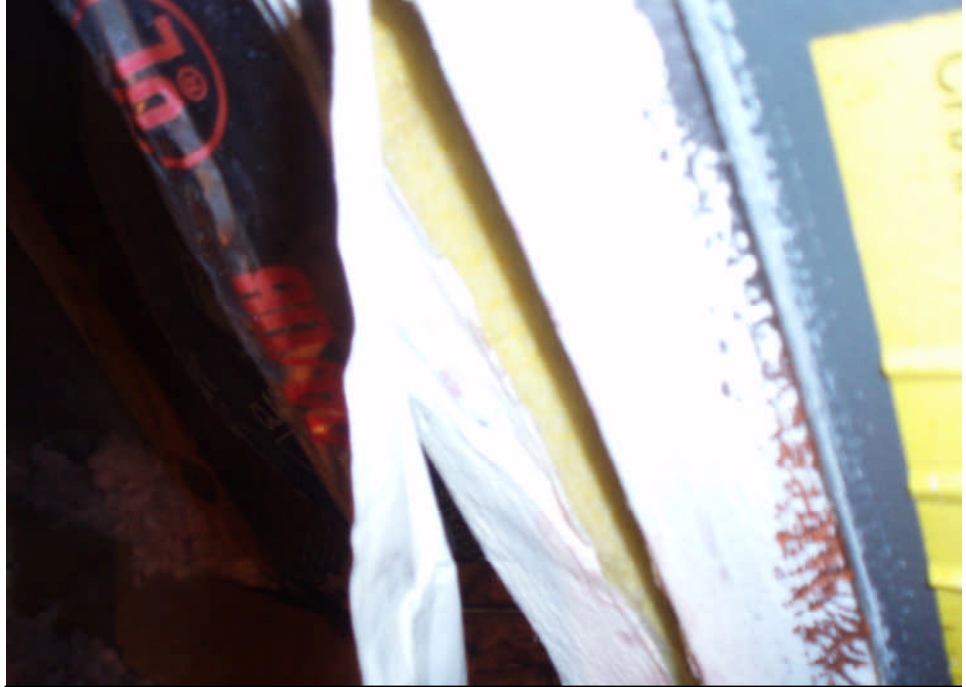
Return air leak at air handler. Tape loose

Return air leak noted at air handler. Duct seams leaking conditioned air in multiple locations. Suggest further review/repair by a licensed HVAC Contractor.

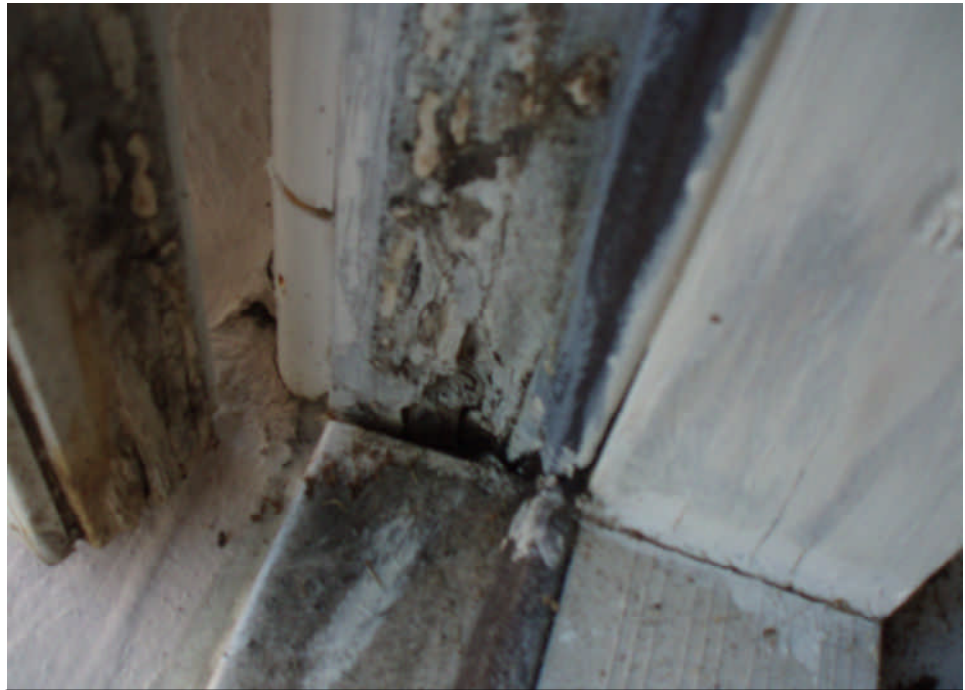
Deterioration garage service door.

**Garage service door deteriorated at door, jamb and trim.
Dining room slider difficult to operate rear right. Left dining room slider caulked shut.
Master bedroom right slider latch is missing.**

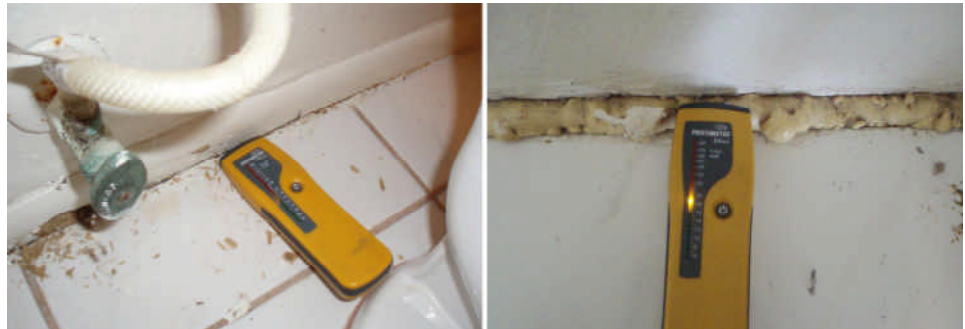
Deterioration/moisture bath and kit. walls

Stains / deterioration noted at hall bath baseboard. Movement noted in wall behind toilet and adjoining kitchen wall. Tested active at the time of inspection. Suggest further review/repair by a licensed contractor.

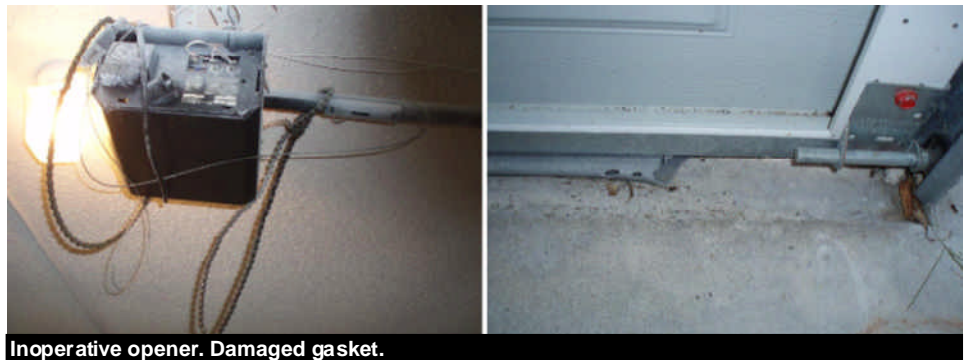
Inoperative opener. Damaged gasket.

Sears. Automatic door opener is inoperative. Gasket damaged bottom left of garage door.

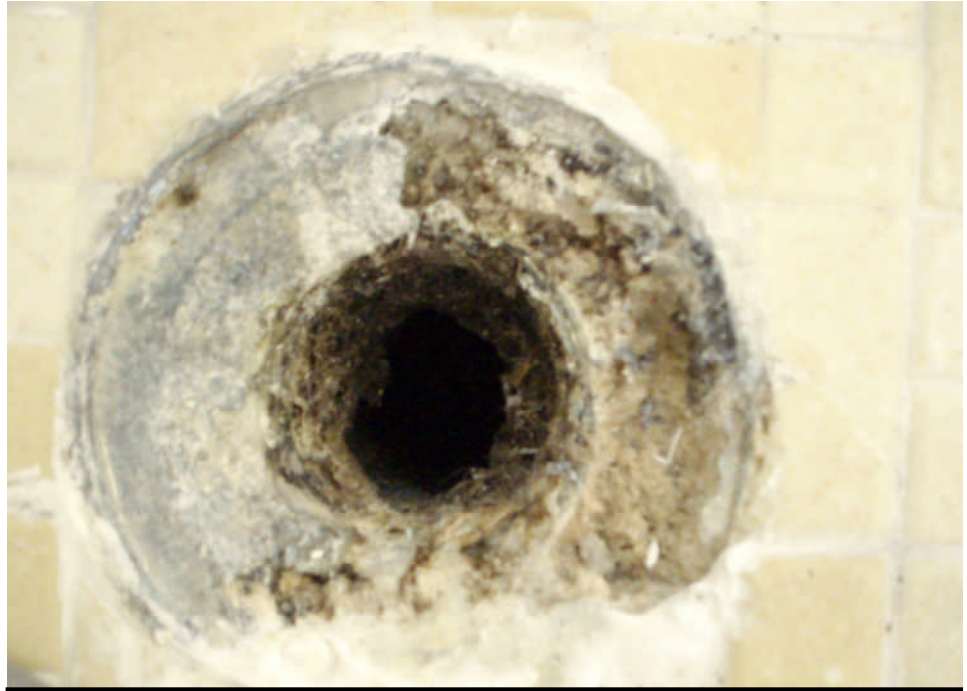
Damaged drain.

Drain is damaged. Suggest further review/repair by a licensed plumber.

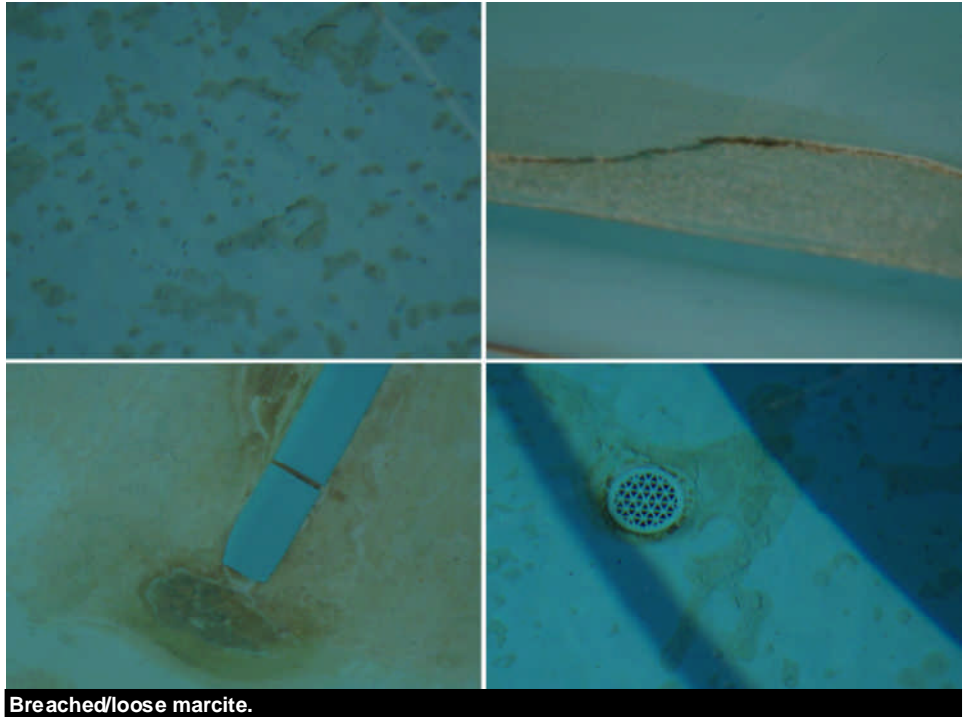
Breached/loose marcite.

Breaches noted in the marcite coating at multiple locations. Marcite is loose in multiple locations. Suggest further review/repair by a licensed pool contractor.

Tiles are cracked in multiple locations above the water line.

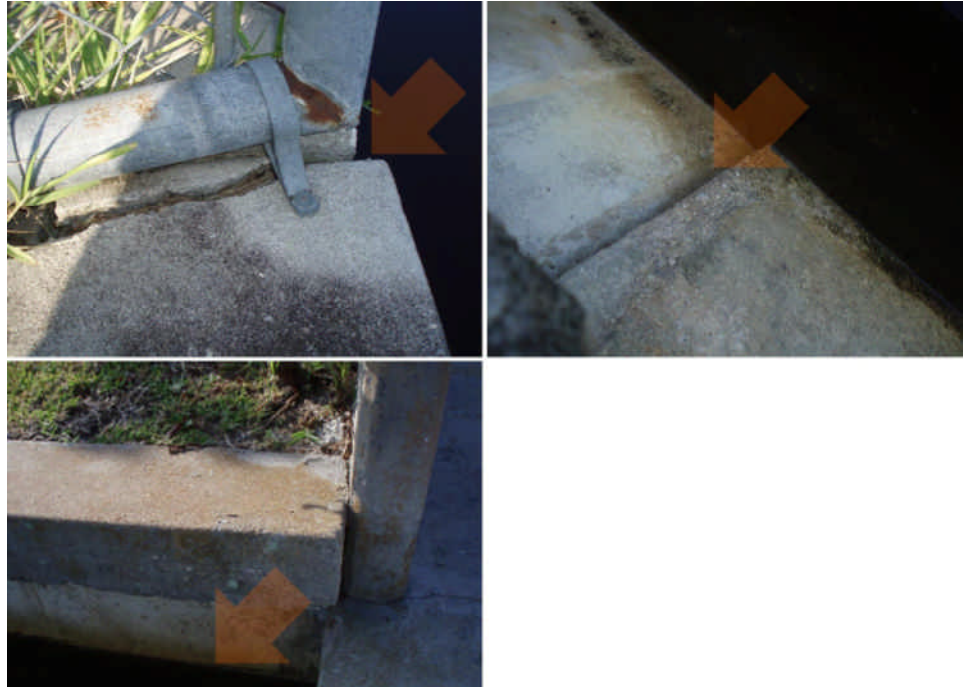
Movement in wall. High Water.

Movement noted in sea wall at left side. Suggest further review/repair by a licensed marine contractor.

Cracks noted in sea wall cap. High water inhibiting visual inspection of sea wall.
